GeoArch

Report 2001/05

Watching Brief on developments at Llandaff Cathedral School

Watching Brief on the Developments at the Cathedral School, Llandaff

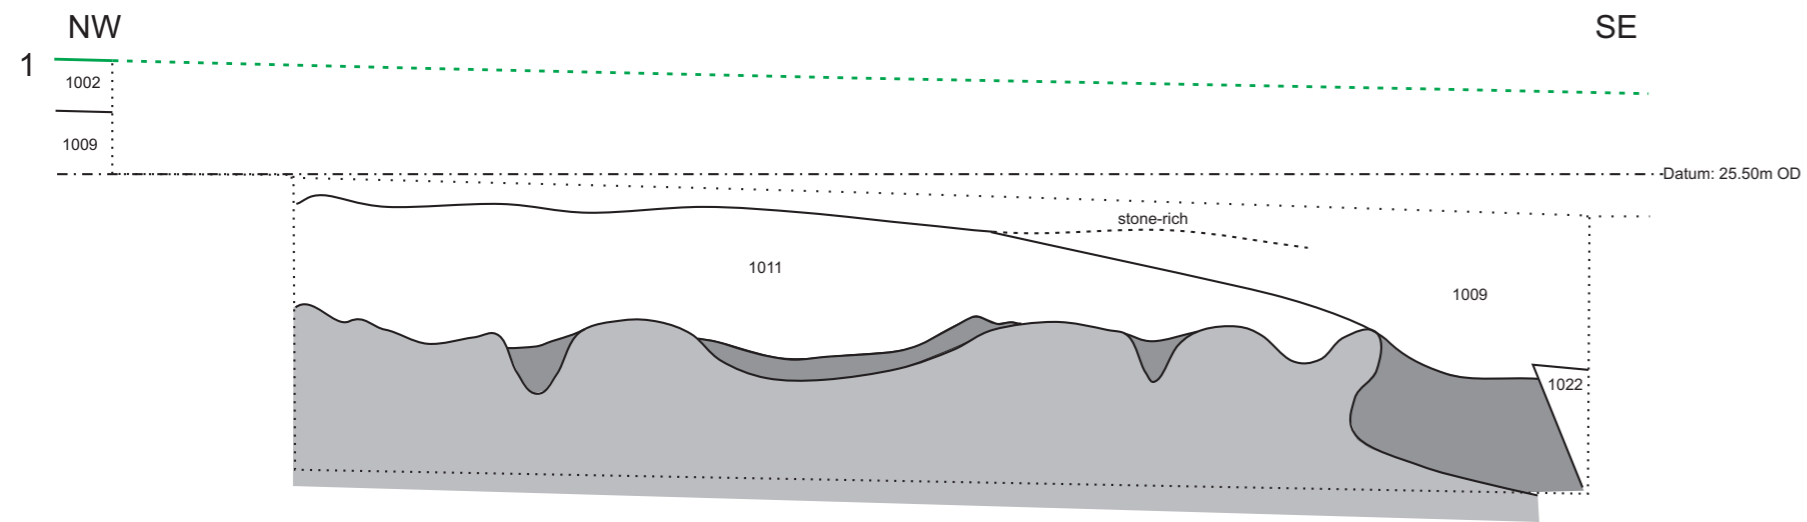
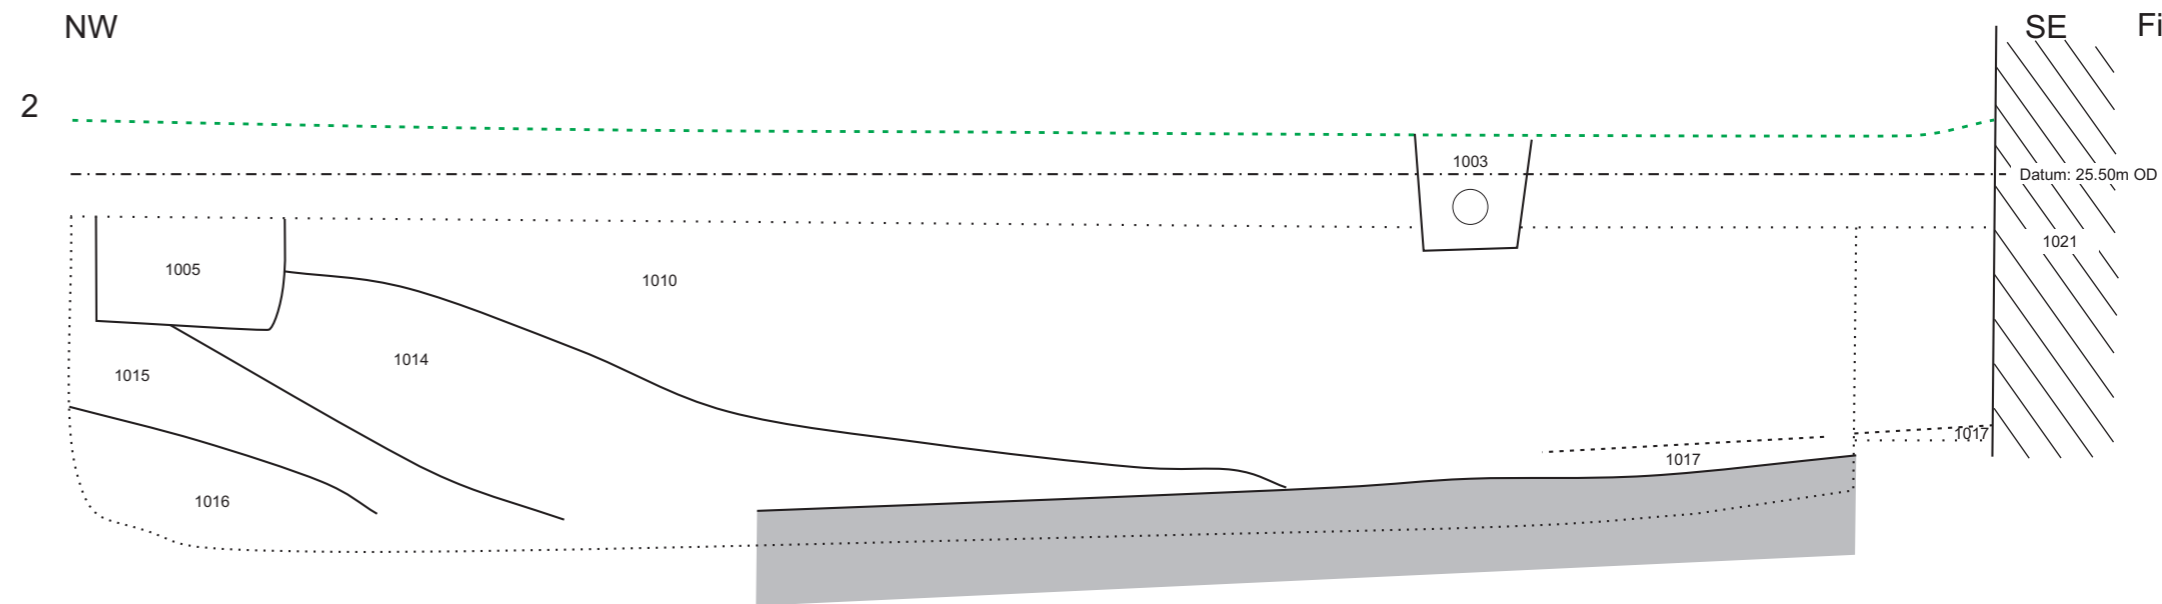
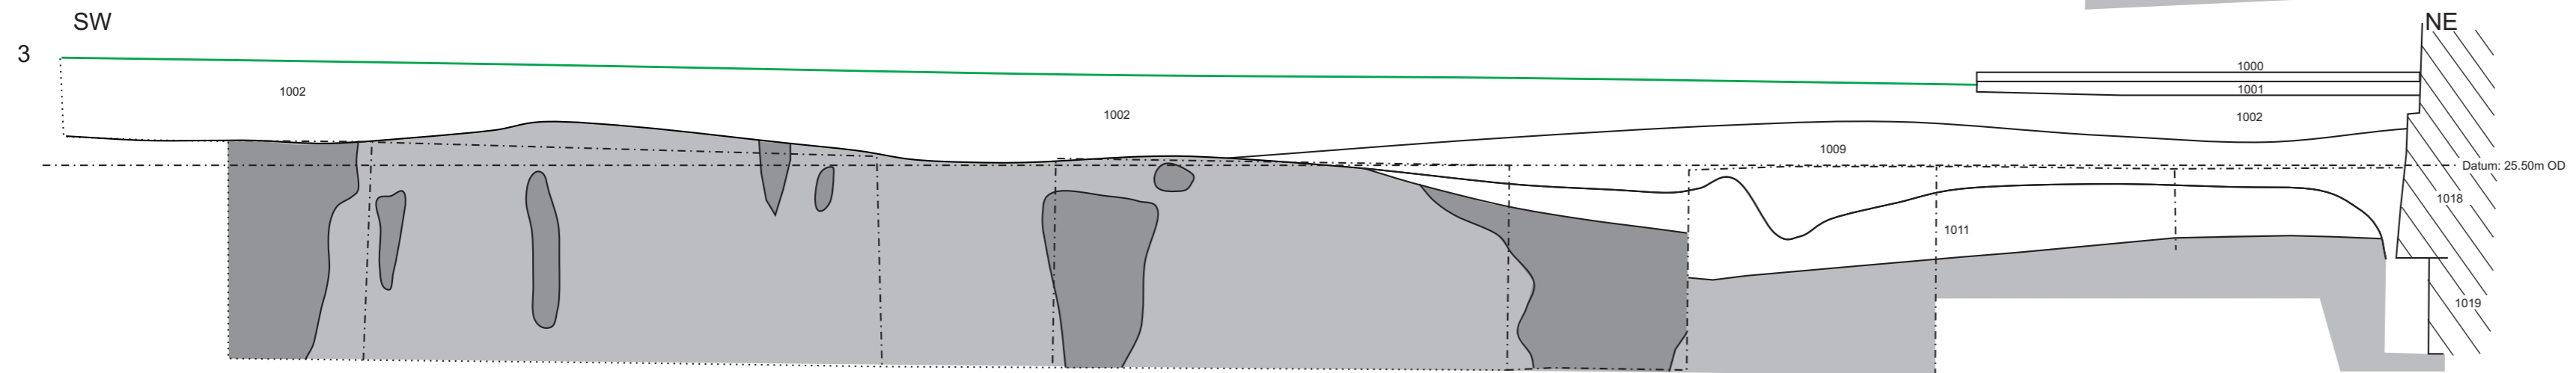
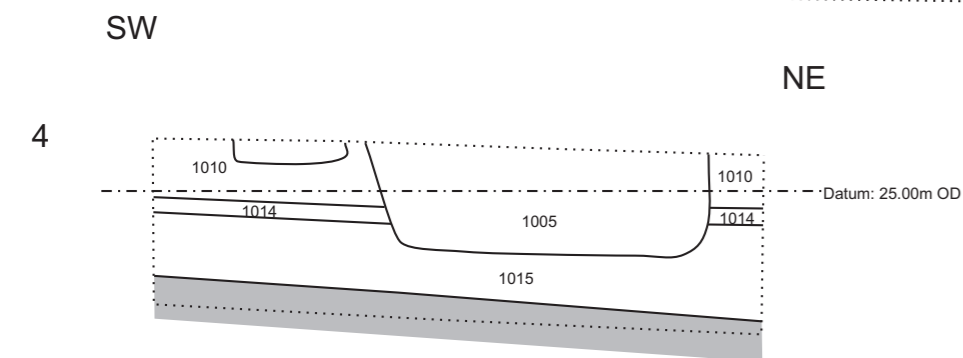
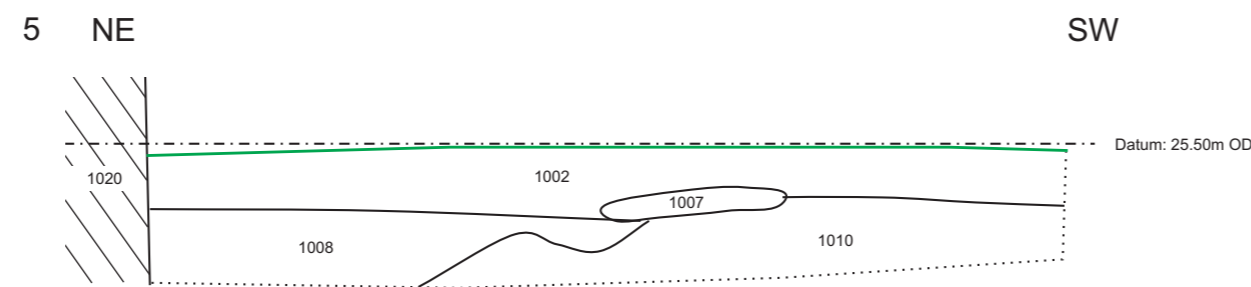
Figure 3

Figure 3. Phase 1: Sections.

Llandaff School: The Nursery Building

The use of the site as a garden since at least the late 18th century is reflected by the great depth of topsoil (1002). The marked thinning of this layer on the NW section about 3m from the wall (Fig. 3, Section 3) and the rubble and mortar lens (1007) 2.2-3.4m from the wall further east (Fig. 3 Section 5) correlate closely with the line of a garden path located in a 1m square test pit dug just to the west of the site by the Cathedral School Archaeology Club as a pilot for Channel 4's "Time Team Test Pit Challenge" in August 2001. This path was surfaced with cinders 0.12m thick (surface at 0.25m below surface), overlying a boulder-filled gully, 0.20m deep, as a base which probably provided drainage. The SW edge of the path was 2.75m from the wall; the NE side was not seen. The line of the path is

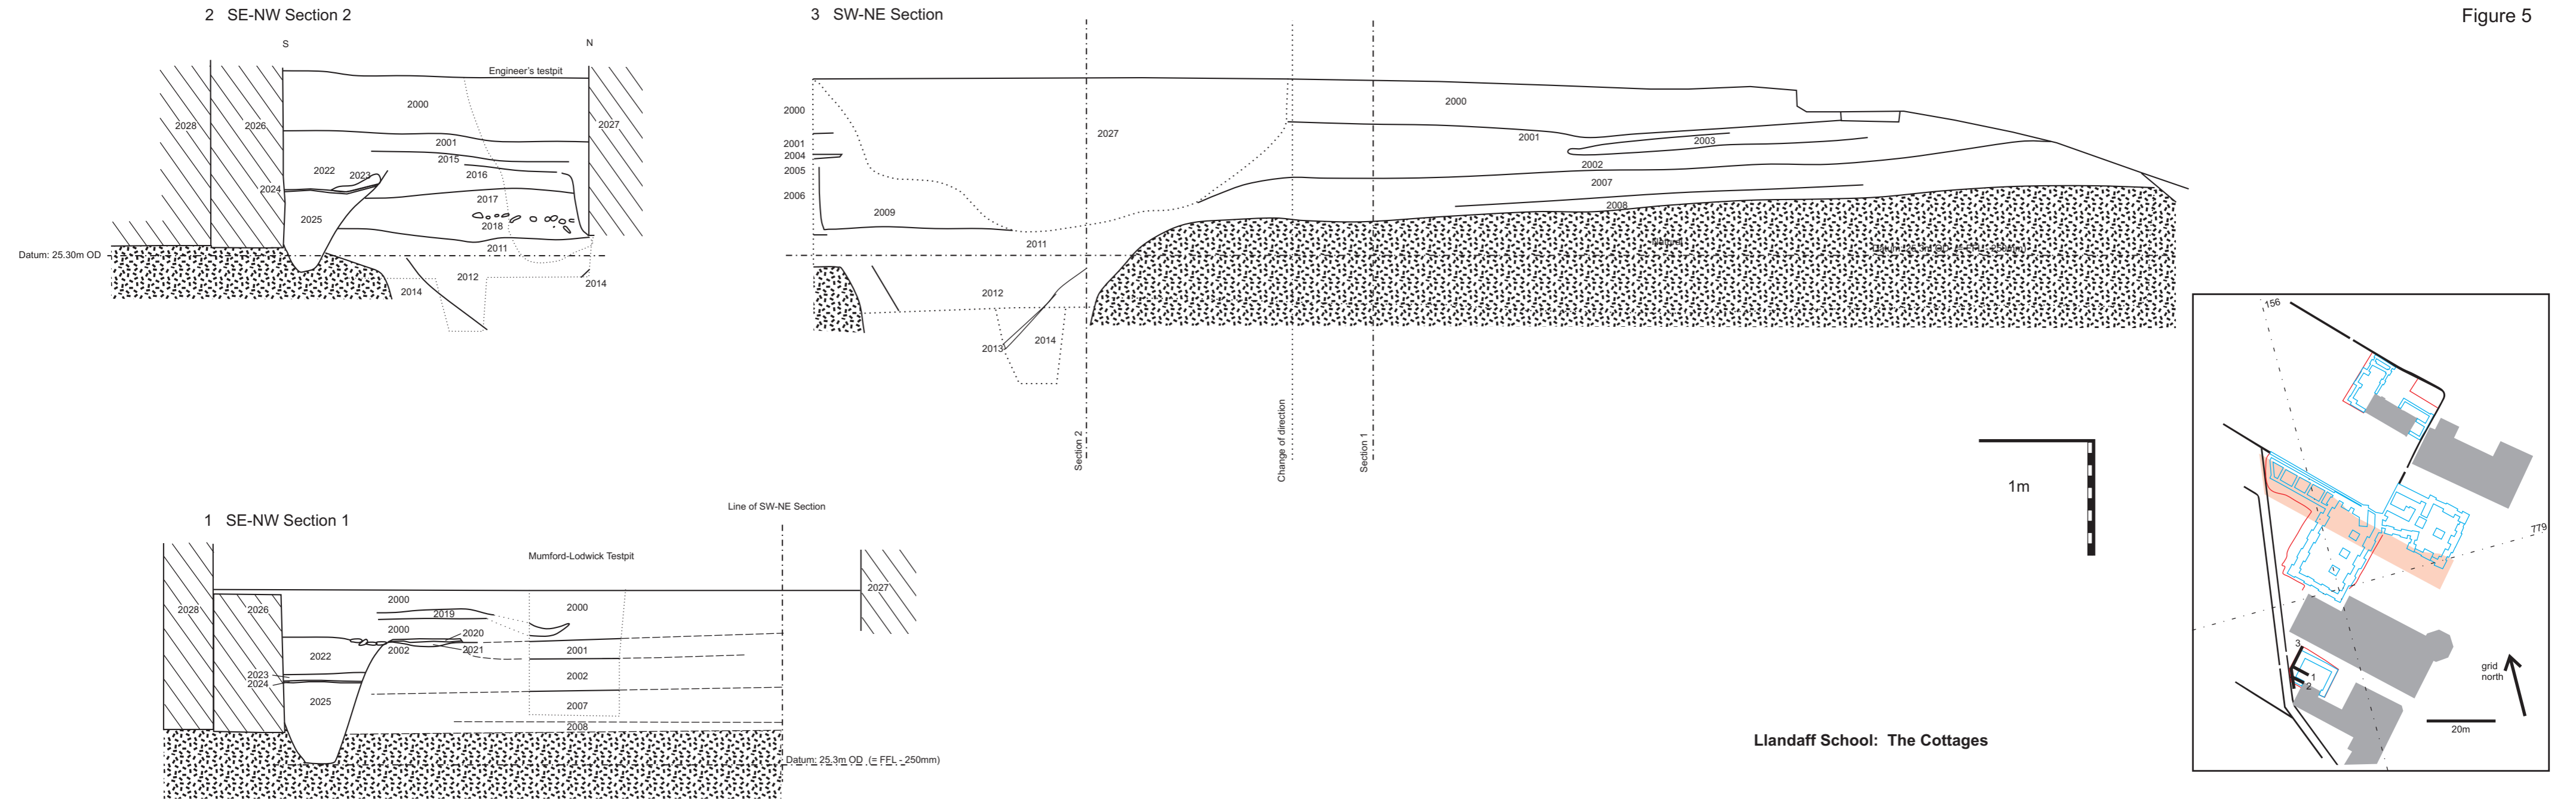
Figure 5. Phase 2: Sections in former garden area.

Llandaff School: The Cottages

(d) View N on completion of ground works showing the section illustrated in Figure 5 section 3, with the left hand side of the picture approximately on the intersection of that section with section 2.

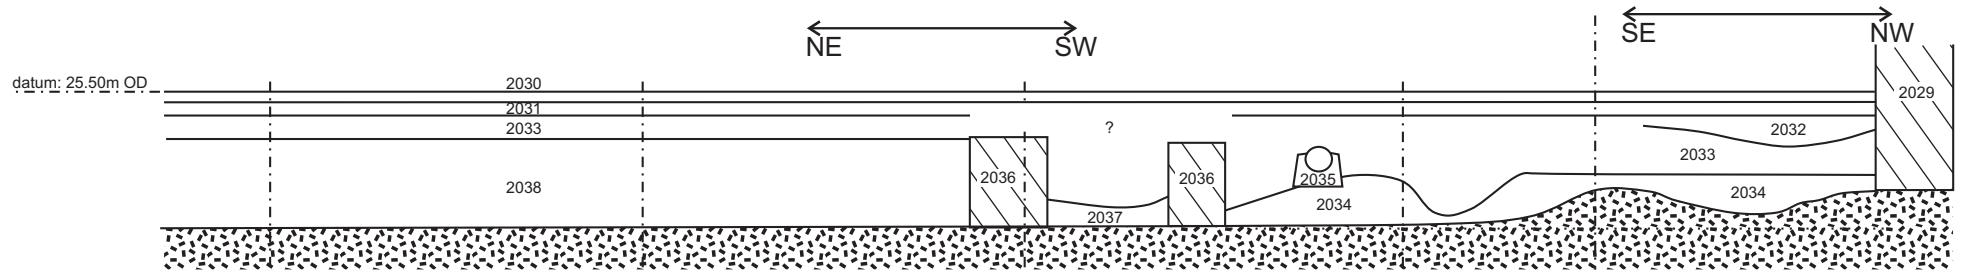
Figure 6

Figure 6. Phase 2: Section in courtyard

Llandaff School: The Cottages, courtyard

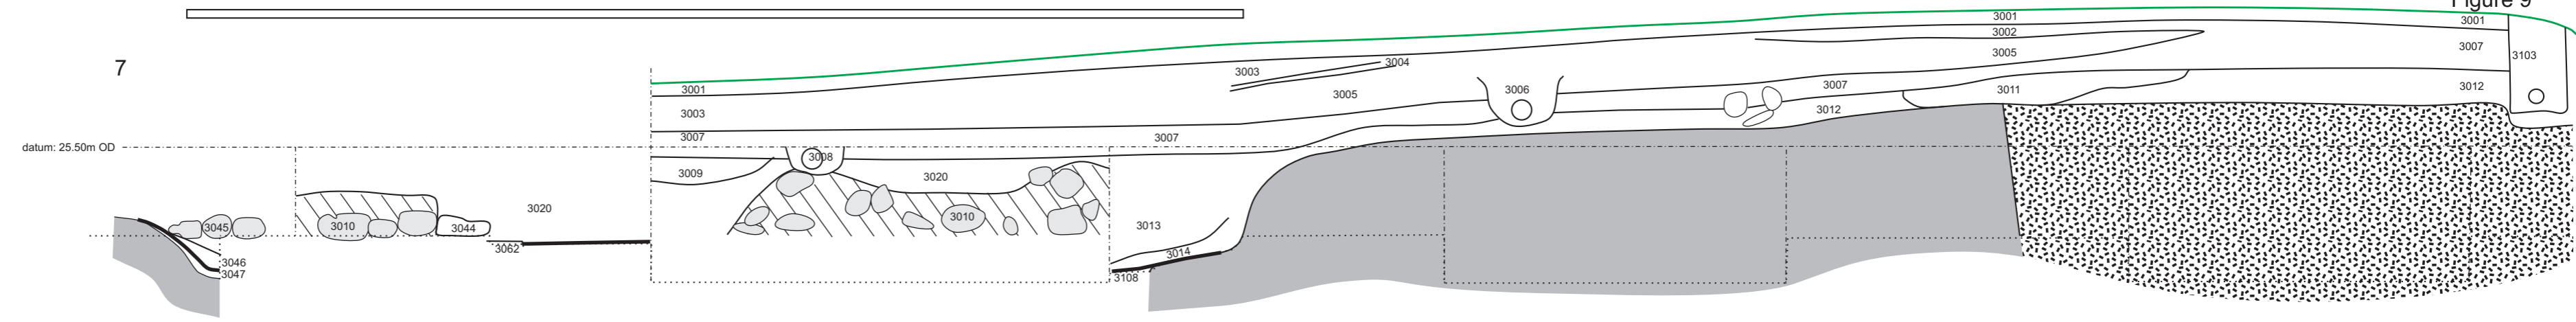
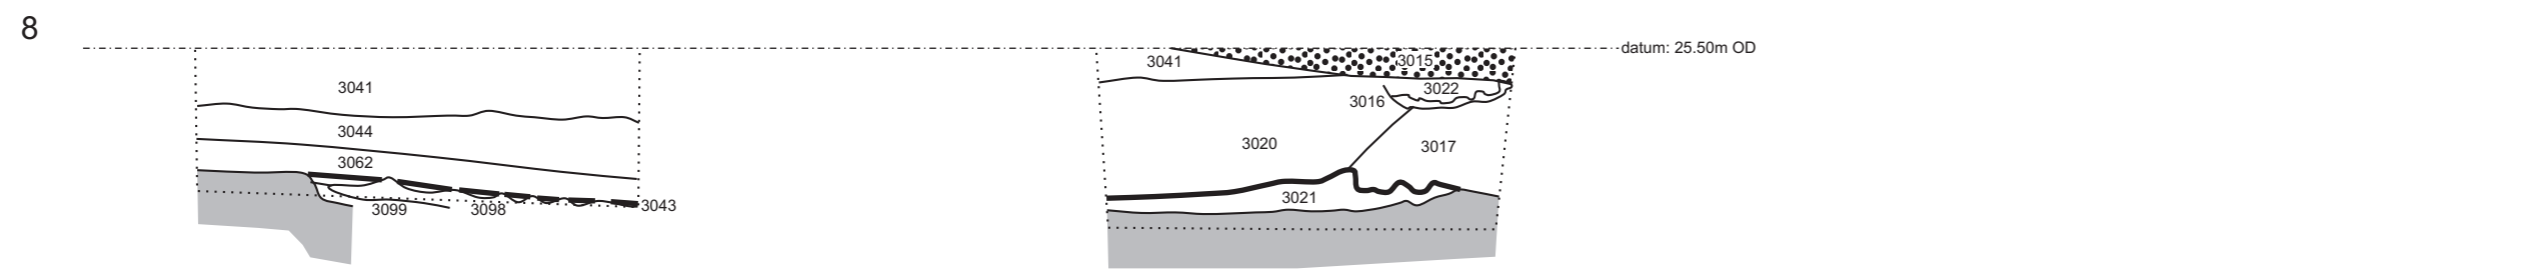
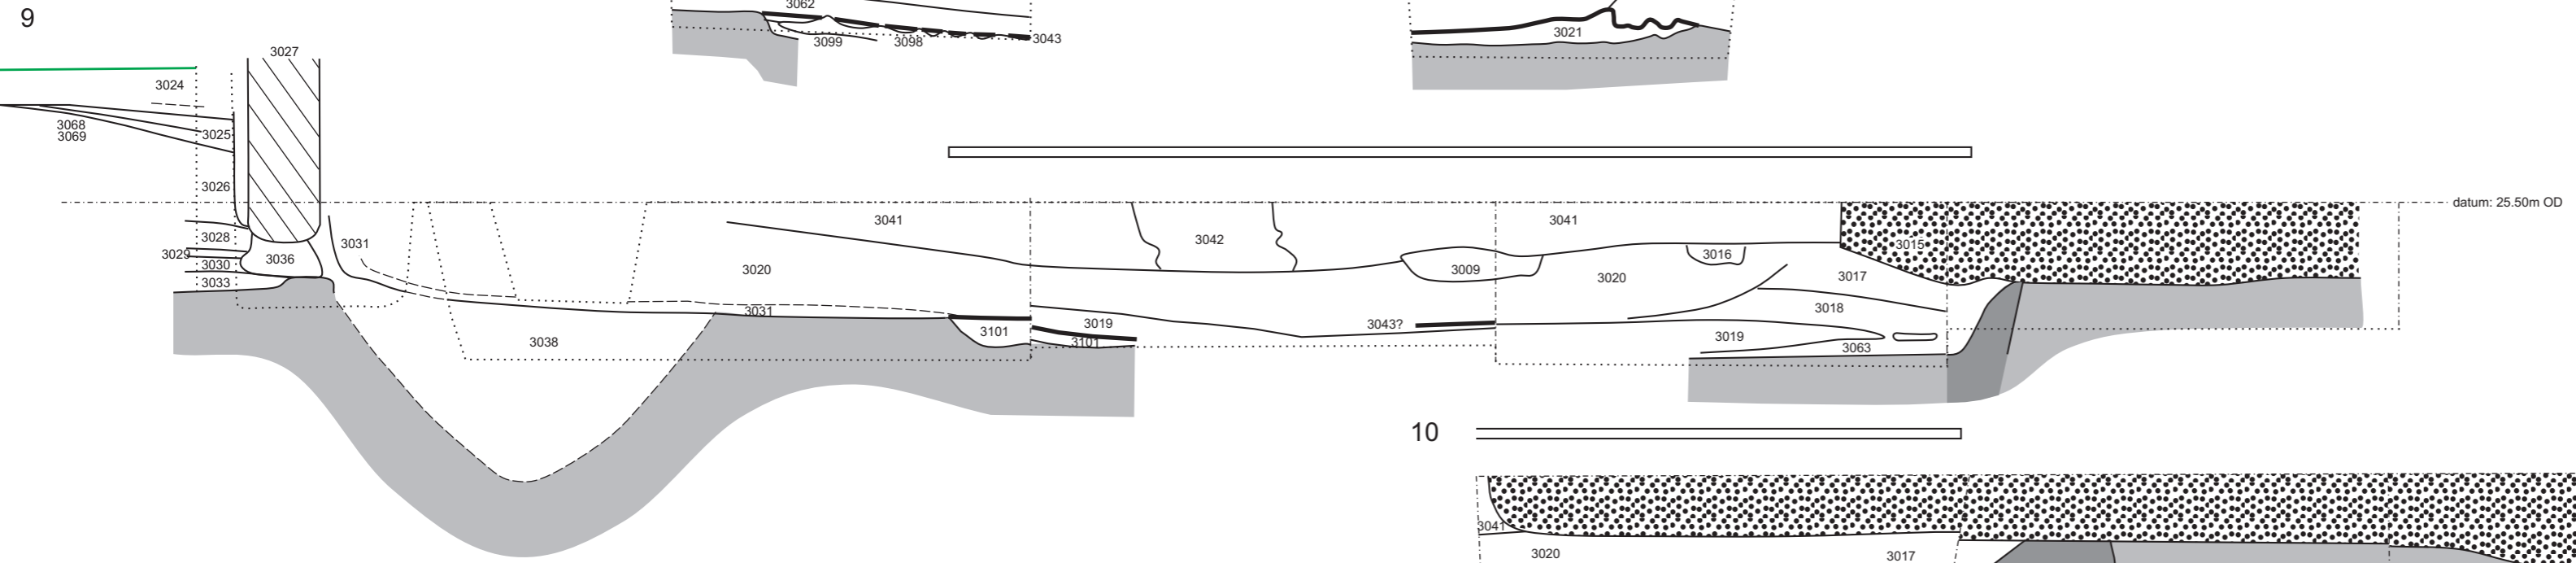
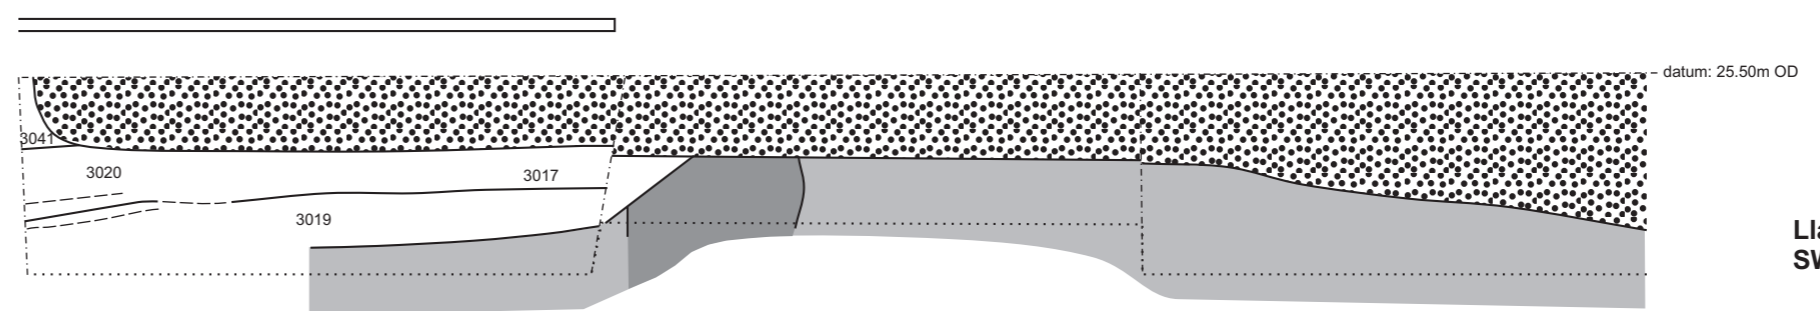
Figure 9

Figure 9. Phase 3: SW-NE sections 7-10. Sections 8 and 10 reversed.

Llandaff School: The Music, Drama, Science Building
SW-NE Sections 7 - 10

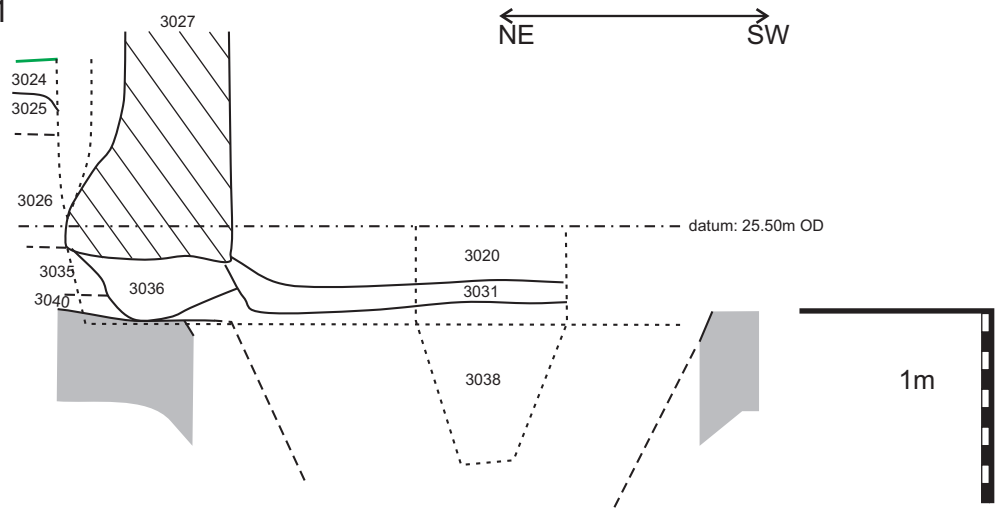
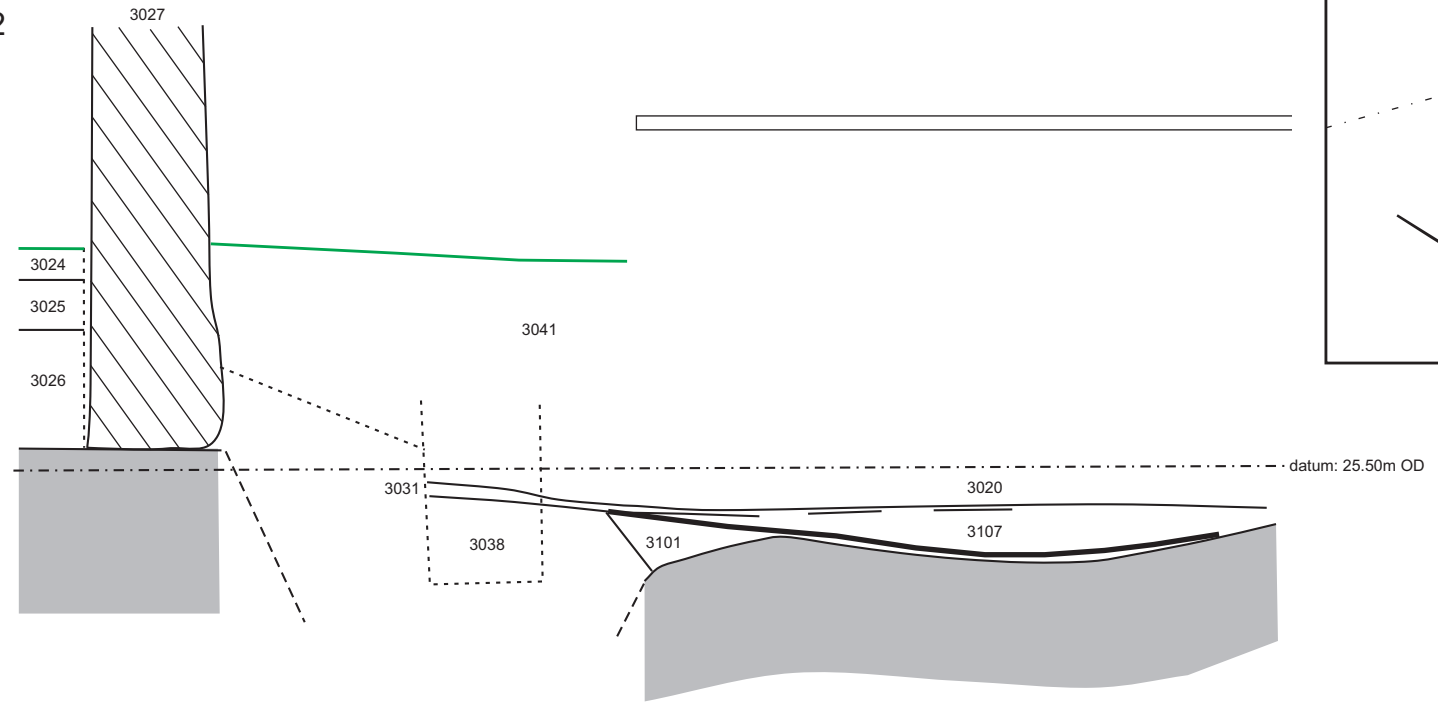
Figure 10

Figure 10. Phase 3: SW-NE sections 11-12. Section 12 reversed.

Llandaff School: The Music, Drama, Science Building
SW-NE Sections 11 - 12

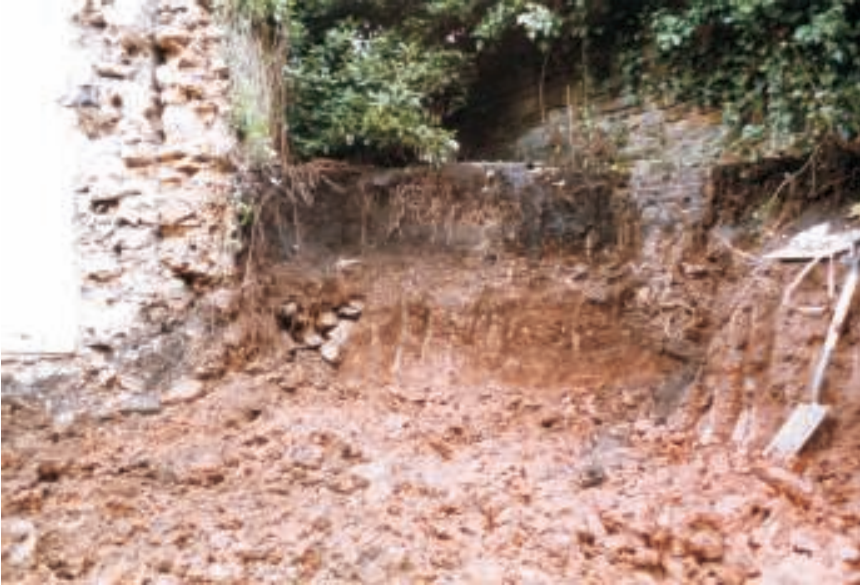
(a) View SW across the Phase 2 site parallel to the line of the former estate wall. Section at far end as drawn in Figure 5 section 2 (i.e. not yet dug to the full length). The estate wall (2026) is preserved to the level of the first floor in the building to the east (left). The cobble fill of the conduit (2025) is clearly visible close to the estate wall.

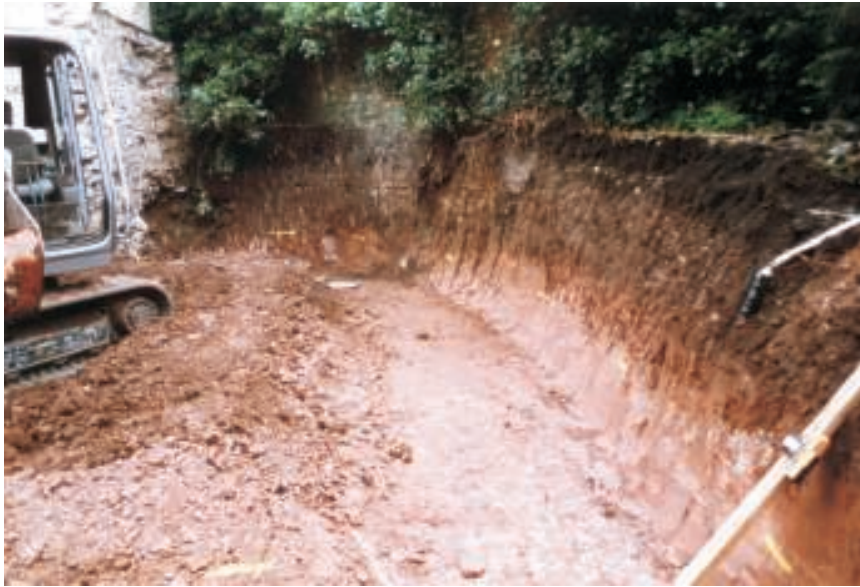
(c) View as in (a) on completion of groundworks.

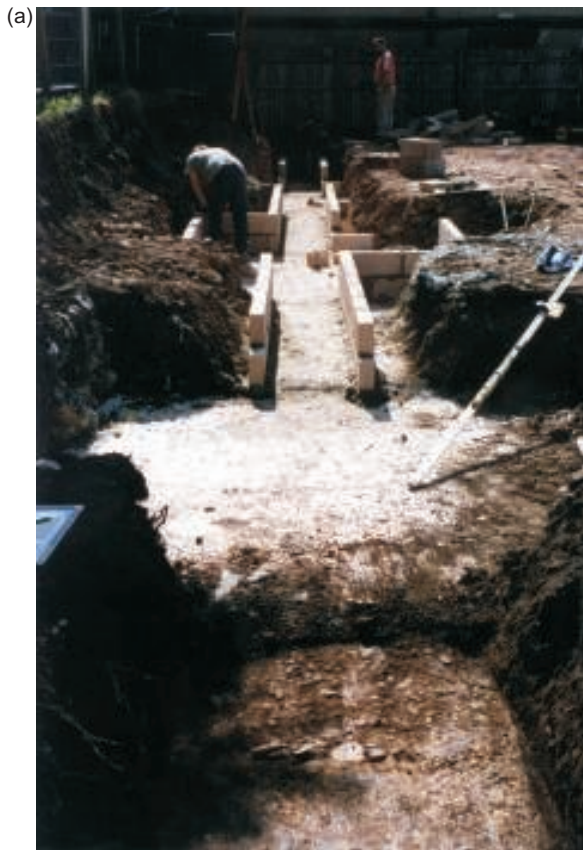
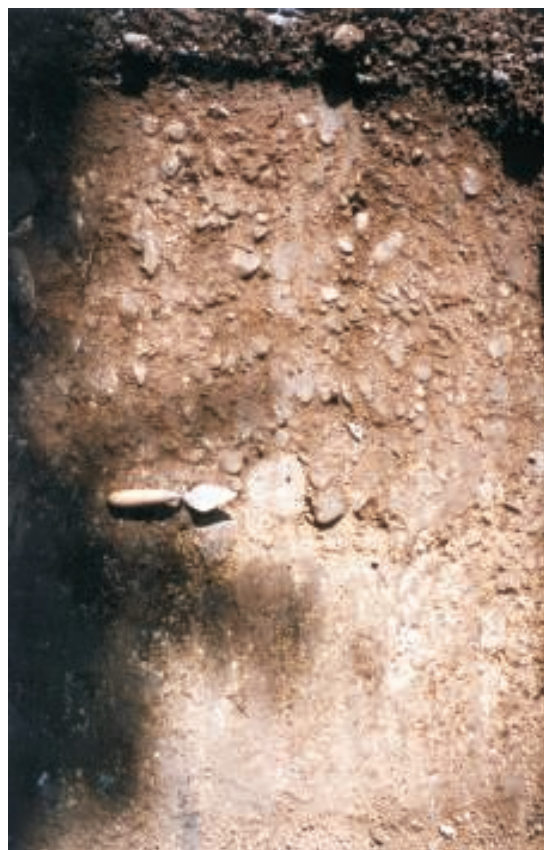
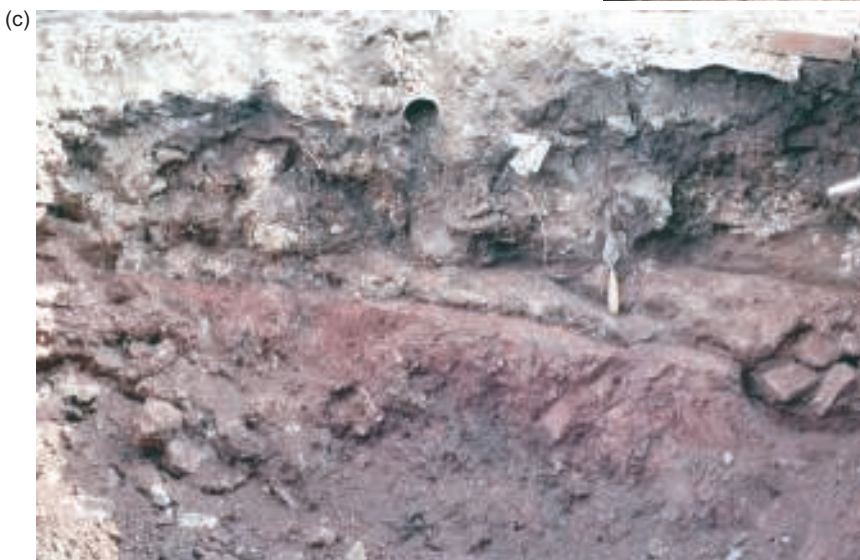
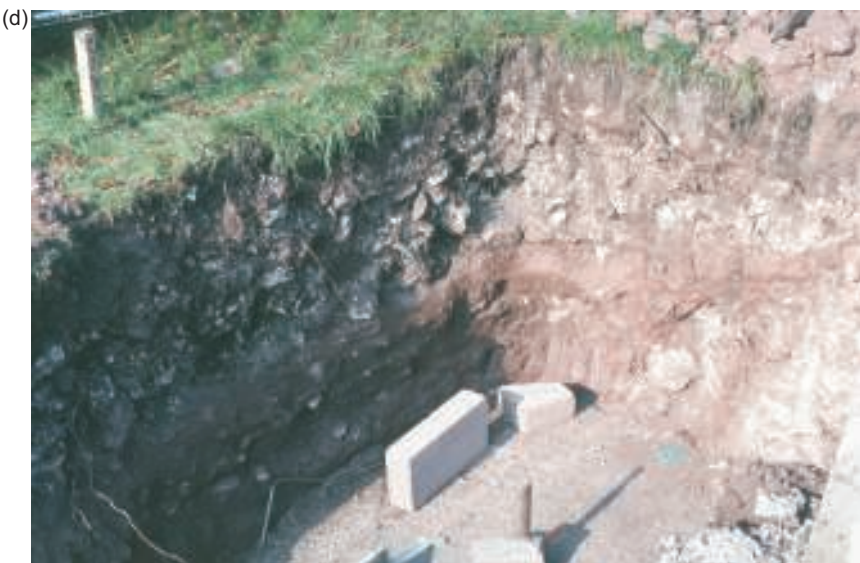
Plate 4

(a) General view of Phase 3 site towards NW from site office. Cathedral in distance, behind Bishops' Castle. S angle tower of castle visible left-centre. SW and SE walls of walled garden removed; temporary fencing in place. E edge of road visible in trench in lower left centre (see also Plate 5 and Figure 8 section 4). Blockwork replacing wall along SW (left) side of walled garden finishes close to point at which medieval ditch swings away from road.

(b) Hand-dug test pit Tr3 (see also Figure 10 section 11) looking NE. Face to rear shows medieval spoil (3026) capped by garden soil. Rubble in background is stone from demolished wall, lying on pre-development ground surface. Post-medieval garden wall footings (3027) visible to left of trench. Rounded pebbles in trench below the medieval revetment (3036). In the foreground the pit is cleared to the level of a cut surface (3067), extending to the NE of the road. Trowel to left of trench for scale.
